Fixing the Cobra Trailer Tongue Bolt breakage issue

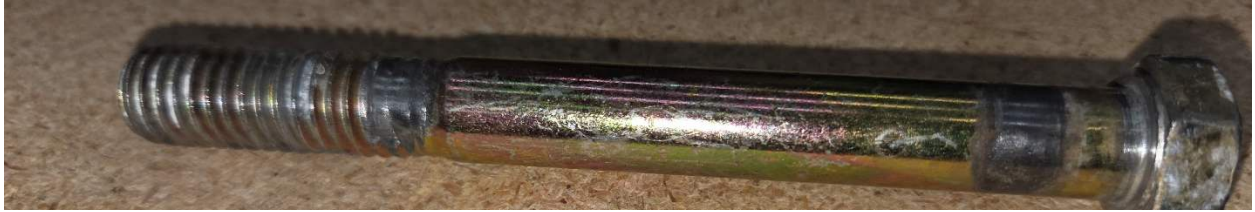
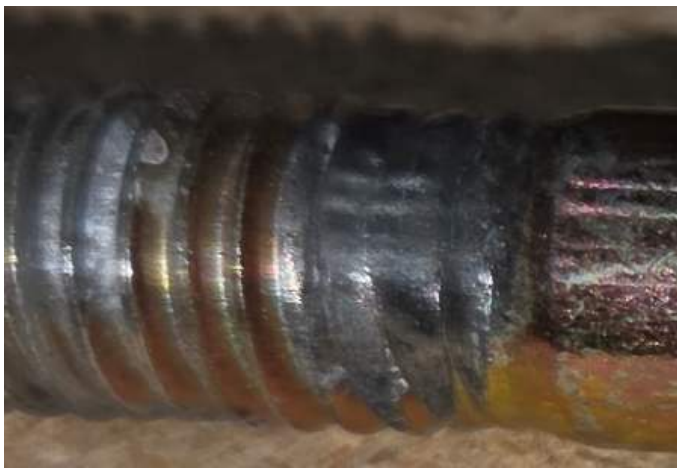
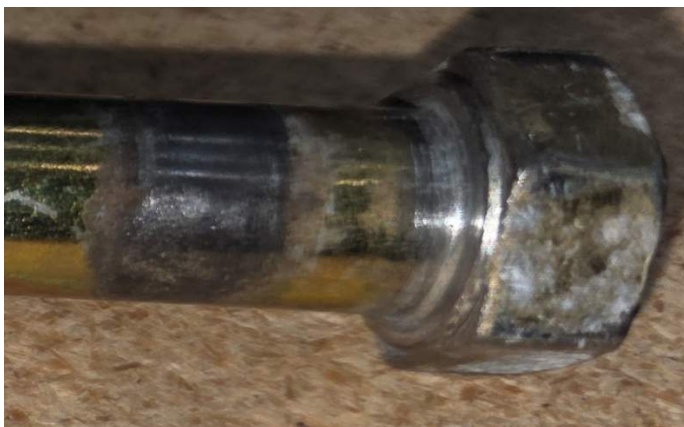
Here is the picture of the front bolt I removed from my cobra trailer tongue.

This is not the original bolt, it's a 7/16" tractor supply special. Probably installed after the original bolt broke, as a field expedient repair.

As the trailer went over bumps the two parts of the tongue moved with respect to each other and in my case hammered into the front bolt like an underpowered shear. Eventually the hammering gets all the way through the bolt, and it fails.

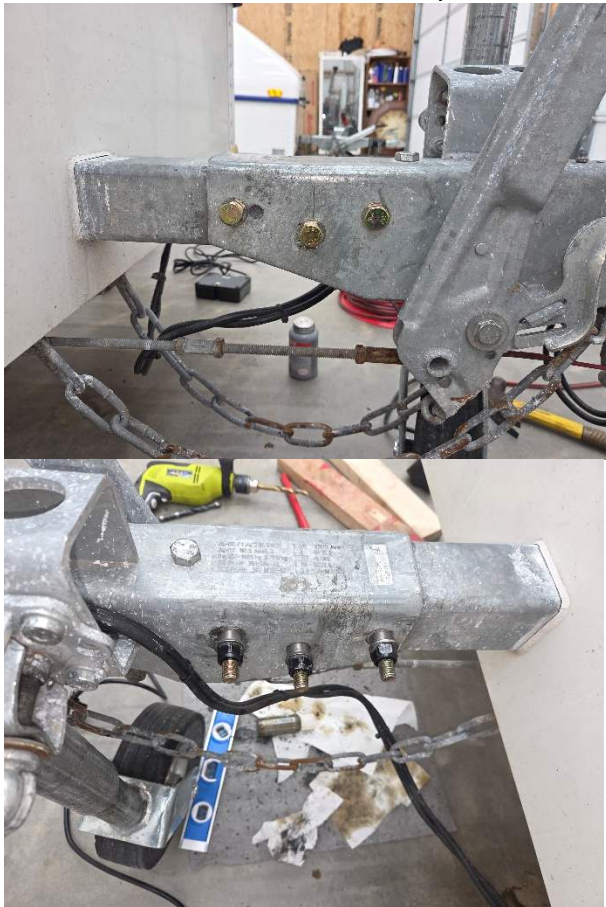
This is what it will look like when you are done

One at a time, replace the existing (2) bolts with the new bolts with the new bolts.

Washer under the head, slide it through the hole. Fill the valleys of the threads completely with Anti-Seize, then slide on the spacer, another washer, then the nut. Jack stands under the front corners of the trailer, and a lightly tensioned bottle jack under the trailer coupler help keep things where they should be and assist with getting everything to line up. Then snug these up, don't torque them up yet.

Drill a 13mm hole for the third bolt. You want to drill this hole roughly slightly aft of center of the original bolts. You want to drill through the side wall of the square tube, as close to the bottom of the square tube as you can get without drilling into the bottom of the square tube. You are probably doing this by hand, give yourself a little room above the bottom of the tube, it's not going to be, and it does need to be a precision hole. Drill it from one side with bits long enough to go all the way through. This is the toughest part of job, if you are inexperienced, seek assistance with this step. A broken drill bit inside the tube will ruin your week. Be very careful with that small bit that you use for that first hole.

Install the third bolt like the original two.

Torque them down to 70 Ft-Lbs

Pattern: middle-Aft-Forward

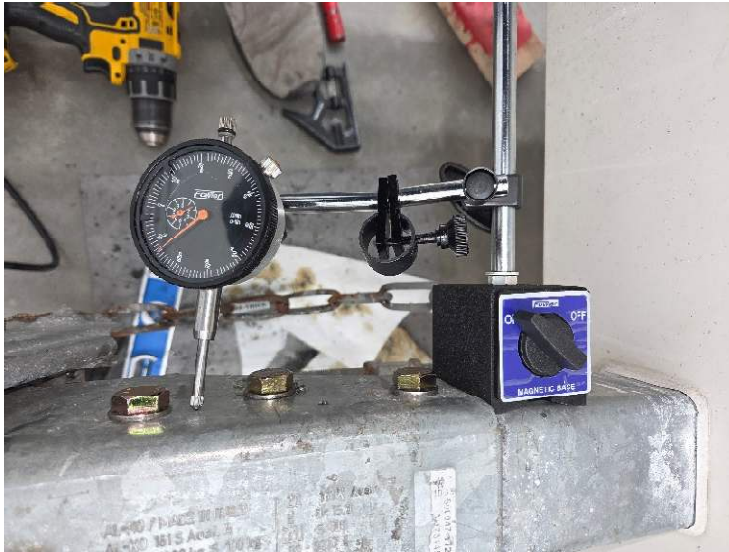
(this Picture is of the dial indicator setup used on final torque of front bolt, 0.0136" movement from Loose to full torque)

Dial indicator movement while torquing the bolt down indicates that you are moving the two pieces into contact with each other bending metal and consuming torque intended for clamping, once it stops, the bolt torque from that point forward is being used for clamping.

Doing this with the original two bolts indicated that the front bolt wasn't doing any clamping at full torque, and the rear bolt only started clamping very near the end of torquing it down. So... no clamping from the front bolt, and only a little clamping from the back bolt.
