Winter 2001 - Installation of Wedekind Sleeves

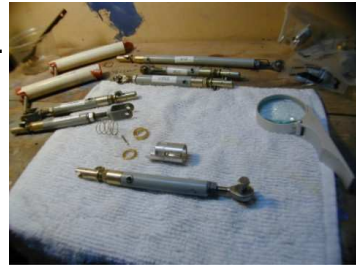
In the center of the towel are the pieces of the Wedekind sleeve. The spoiler link is first to be modified. I cleaned the Hotelier connection thoroughly with alcohol and a brass brush. Using a strong light and a magnifying glass, I carefully inspected each piece of the arm, rod ends and connection mechanism to detect any cracks, corrosion or other damage. They appear to be in excellent condition

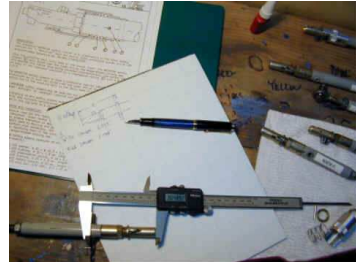
I measure the length of each control rod prior to disassembly and record the length to insure that the rod is re-assembled correctly after the modification.

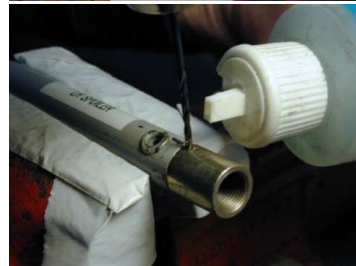
Using a 2mm drill and some cutting fluid, I drill the roll-pin hole through one side of the control rod.

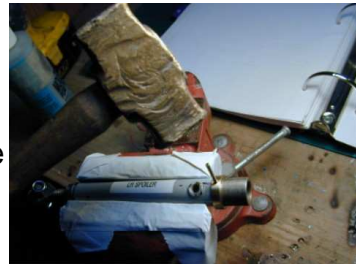
I tap the roll-pin into the bronze bushing and the hole I just drilled. This will hold the bushing in proper position while I mark and drill the hole in the opposite side of the control rod

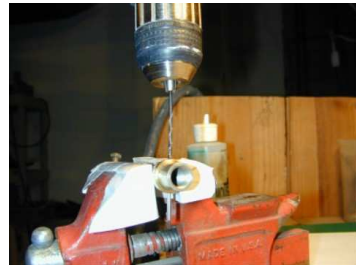
you can see the roll-pin sticking out of the bronze bushing on the bottom of the control rod while I drill the opposite hole. This will insure perfect alignment. Use lots of cutting fluid as this is hard steel.

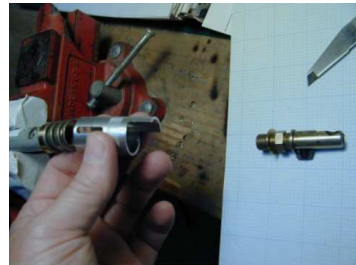
Holes drilled, bronze bushing, spring and safety sleeve assembled, ready for the roll-pin and the Hotelier connection.

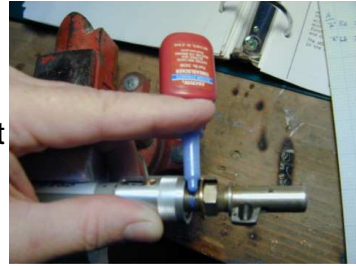
With roll-pin partially tapped in to hold the safety sleeve in place, I put some medium Loc-Tite onto the Hotelier threads to help secure the rod-end. It's not required, but I'm a big fan of Loc-Tite - this Hotelier will not inadvertently back off!

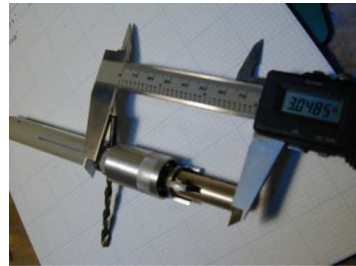
With the Hotelier rod-end lined up with the original marks I made and the lock-nut tightened and roll-pin driven all the way in; I measure the overall length one last time to insure correct assembly and it's all done.

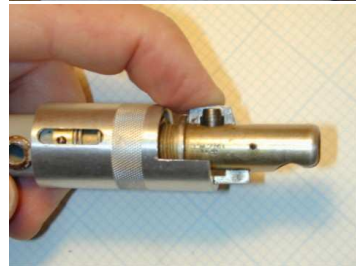
Here's how it works: with the spring holding the safety sleeve forward against the bronze washer, the Hotelier wedge is captured by the safety sleeve and cannot open enough to release the rod-end ball (when it is connected).

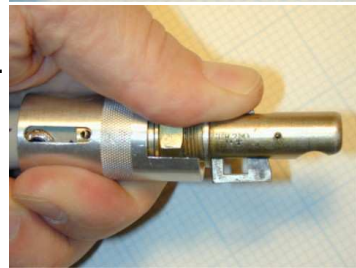
With the safety sleeve pulled back against the spring, you can push the Hotelier wedge into the open position. The roll pin holds the bronze bushing in place - that provides a backstop for the spring, and the pin also sticks up out of the bronze bushing about 2mm to ride in the safety sleeve slots - that keeps the safety sleeve from rotating away from the wedge-capture position.
