Winter 2001 - Installation of Wedekind Sleeves

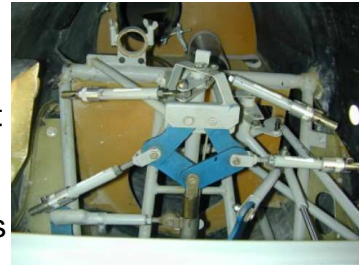
23 December 2001 is another beautiful sunny day in Connecticut, so I install the control arms back into the Nimbus - only the flap arms remain to be completed when the last sleeve arrives from Knauff and Grove. The spoiler control rod attach bolt at the top of the photo is in upside-down from what you might consider normal - important to re-install all hardware exactly as it came out because those bolt heads must be properly oriented to clear everything it may swing next to. The complex geometry of the Nimbus control system means that full and complete functional checks must be completed after this is all done, one never knows what one may have done inadvertently that may limit or interfere with control travel.
